CAPITAL RESERVE STUDY

CATEGORY II: UPDATE WITH ON-SITE REVIEW

FERNBROOKE HOMEOWNERS ASSOCIATION FERNBROOKE DRIVE WESTAMPTON, NJ 08060

Fiscal Year: 2018
Fiscal Year Date Span: January 1, 2018 - December 31, 2018
Care of: Access Property Management
455 Larchmont Blvd, Suite 14A
Mount Laurel, NJ 08054
Job Number: 2946.0004
Prepared: April 2018
Finalized: February 2020

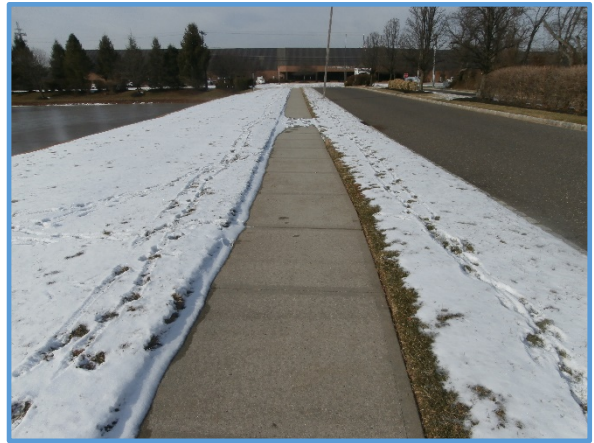
Concrete Sidewalk

The common area sidewalks throughout the community are constructed of Portland Cement concrete, which has a typical useful life of thirty (30) years. The sidewalks were observed to be in average condition, with isolated areas of cracking and displacement observed. Any areas of sidewalk posing possible trip or *safety* hazards should be replaced immediately to eliminate the hazard.

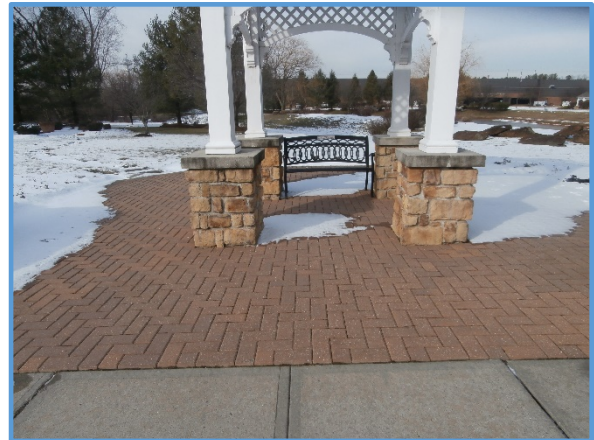
Pre-cast Concrete Paver Pad

Pre-cast concrete pavers are interspersed throughout the community at the main entranceway, roadway cross-walks, and around landscaped areas near the retention basin. Pre-cast concrete pavers have a long typical useful life, but require regular maintenance such as power washing, replenishment of the sand in the joints, and resetting of displaced pavers. The pavers were observed to be in average condition, experiencing displacement in some areas including the paver and concrete sidewalk abutment at the community's shade structure, the perimeter around the paver circle adjacent to the retention basin, the main entry and exit way at Fernbrooke Drive, and at the curb ramps and roadway cross-walks throughout the community.

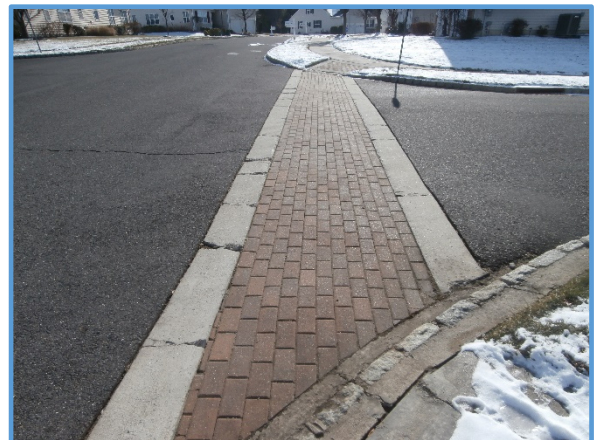
Pre-Cast Concrete Paver Walkway

The paver curb ramps and roadway cross-walks are edged by an approximate 18" wide poured concrete border. The concrete borders have a typical useful life of thirty (30) years. The concrete borders were observed to be in below average condition with deficiencies including cracking with gaps up to two (2") inches wide, spalling, exposed aggregate, premature deterioration, and displacement resulting in potential *safety/trip* hazards. Any trip hazards and areas presenting *safety* hazards should be replaced immediately to eliminate the hazard.

The reserve schedule includes line items for replacing the aforementioned poured concrete borders and resetting of the pre-cast concrete pavers in areas where displacement had been mentioned above. Full replacement of the concrete pavers is not anticipated during the thirty (30) year scope of the reserve study. Any cracked or broken pavers should be replaced through the maintenance budget as needed. The pavers are anticipated to be reset every ten (10) years, which is reflected in the reserve schedules.

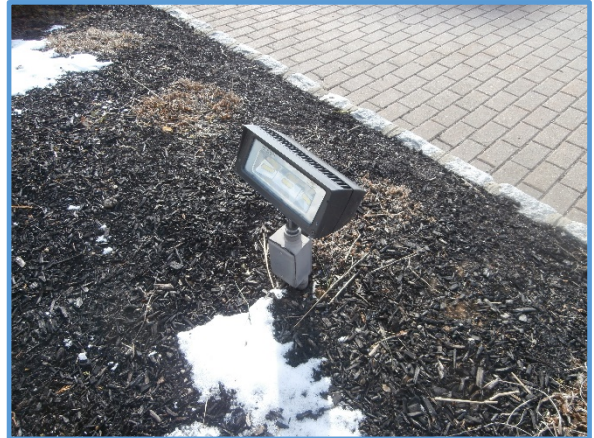
Box Floodlight

The landscaped island between the main entry and exit road (Fernbrooke Drive) is illuminated with LED landscape lights. Exterior lighting has a twenty-five (25) year typical useful life. The lights were observed to be in average condition, having been recently replaced.

The pricing reflected in the schedule anticipates that all the lighting fixtures within the community will be replaced with those of the same size, type, and intensity, with LED bulbs. The lighting replacement cost does not include the replacement of wiring or conduit.

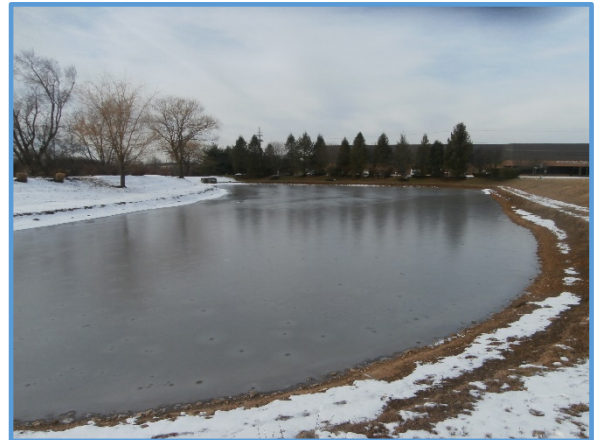
[Retention Basin](#)

One (1) retention basin is located near the main entrance to the community. The basin contains a fountain aerator with a lighting kit. The aerator has a typical useful life of eight (8) to ten (10) years. The aerator was not operating during the time of inspection due to winter conditions. During the study preparations, FWH was not made aware of any functional difficulties with the aerator system. The aerator's remaining useful life has been calculated based off its last known installation year.

It is important to note that portions of the basin bank were observed to be eroding, especially at the northern side of the basin. Visual observations suggest that the erosion is due to stormwater runoff flowing down hill into the pond from the elevated grade above. This erosion should be corrected as the weather permits since the erosion is depositing sediment into the basin and the severity of the erosion will increase if left unaddressed.

Periodic dredging of the stormwater collection pond is required in order to remove accumulated sediment. Best management practices for stormwater basins suggests that dredging should be performed on retention basins or wet ponds every twenty (20) to twenty-five (25) years depending upon the design of the basin, the surrounding areas characteristics, and typical weather patterns. The frequency and cost of pond dredging can vary greatly because it is dependent on numerous factors. The dredging will ensure the basin maintains an adequate depth for a healthy aquatic environment. *Bathymetric soundings (depth measurements) should be conducted to measure the accumulation of silt and gain a better understanding of the dredging scope of work.*

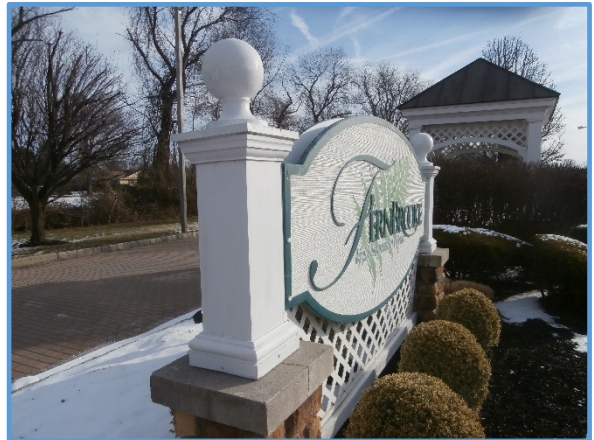
Composite Community Sign

The community entrance sign is constructed of composite material affixed to dimensional wood posts and framing, which are anchored to masonry pillars finished with Adhered Concrete Masonry Veneer (ACMV). Community signs of this type have a typical useful life of twenty (20) years. The composite sign was observed to be in average condition, exhibiting finish failure, staining, and splitting at the bottom of the sign. The dimensional wood posts and framing were observed to be in average condition, experiencing staining and split areas of wood. The masonry pillars were observed to be in below average condition, showing signs of cracking at the limestone caps and cracking throughout the ACMV stone and mortar joints. Repair sealant was present at the cracks within the limestone caps, but the sealant joints were observed to be failing during the time of inspection.

As per the Association, the sign had been refurbished in 2014 through the maintenance budget.

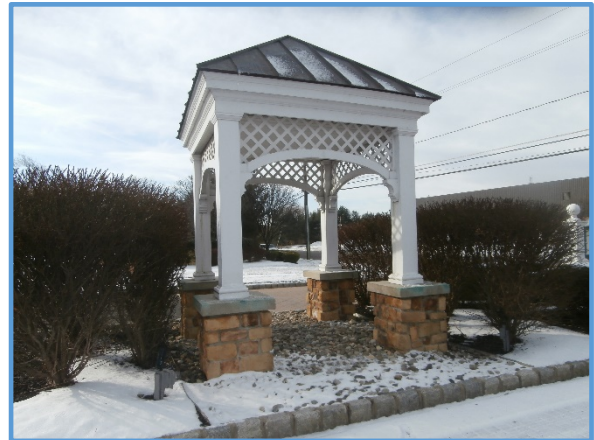
*Shade Structure
(main entry)*

The shade structure adjacent to the entrance sign is constructed of dimensional wood lumber, which sits atop masonry pillars that are finished with ACMV. The shade structure is weatherproofed by a standing seam metal roof. The masonry pillars were observed to be in average condition, showing signs of efflorescence at the face of the ACMV, minor cracking at the limestone caps, and staining. The wood components and vinyl soffit were observed to be in average condition, exhibiting areas of staining. The metal standing seam roof was observed to be in below average condition, with deficiencies including finish failure, staining, and signs of oxidization.

The cost to replace the wood shade structures is included in the schedule and was determined using similar sized shade structures with similar components.

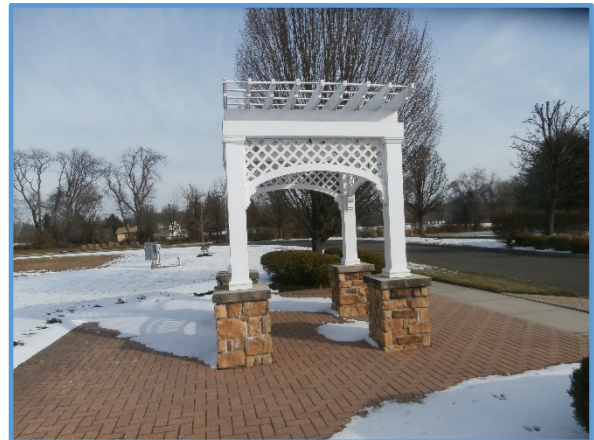
*Shade Structure
(Fernbrooke Drive & Mayfaire Circle)*

The shade structure at the intersection of Fernbrooke Drive and Mayfaire Circle is constructed of dimensional wood lumber, which sits atop masonry pillars that are finished with ACMV. This shade structure has a pergola-style roof constructed of dimensional wood joists. The masonry pillars were observed to be in below average condition, with deficiencies including cracking throughout the stone and mortar joints, efflorescence, and cracking at the center of the limestone caps where the wood posts are affixed to the masonry pillars. The wood components were observed to be in average condition, exhibiting weathered wood members containing signs of splitting and splintering, especially at the roof joists.
